HOUSATONIC RIVER BASIN
HARLEM VALLEY RESERVOIR

DUTCHESS COUNTY, NEW YORK
(INVENTORY NO. N.Y. 273)

PHASE I INSPECTION REPORT,
NATIONAL DAM SAFETY PROGRAM

PHASE I INSPECTION REPORT
NATIONAL DAM SAFETY PROGRAM
HARLEM VALLEY RESERVOIR DAM
I.D. NO. N.Y. 273
D.E.C. NO. 677
HOUSATONIC RIVER BASIN
DUTCHESS COUNTY, NEW YORK

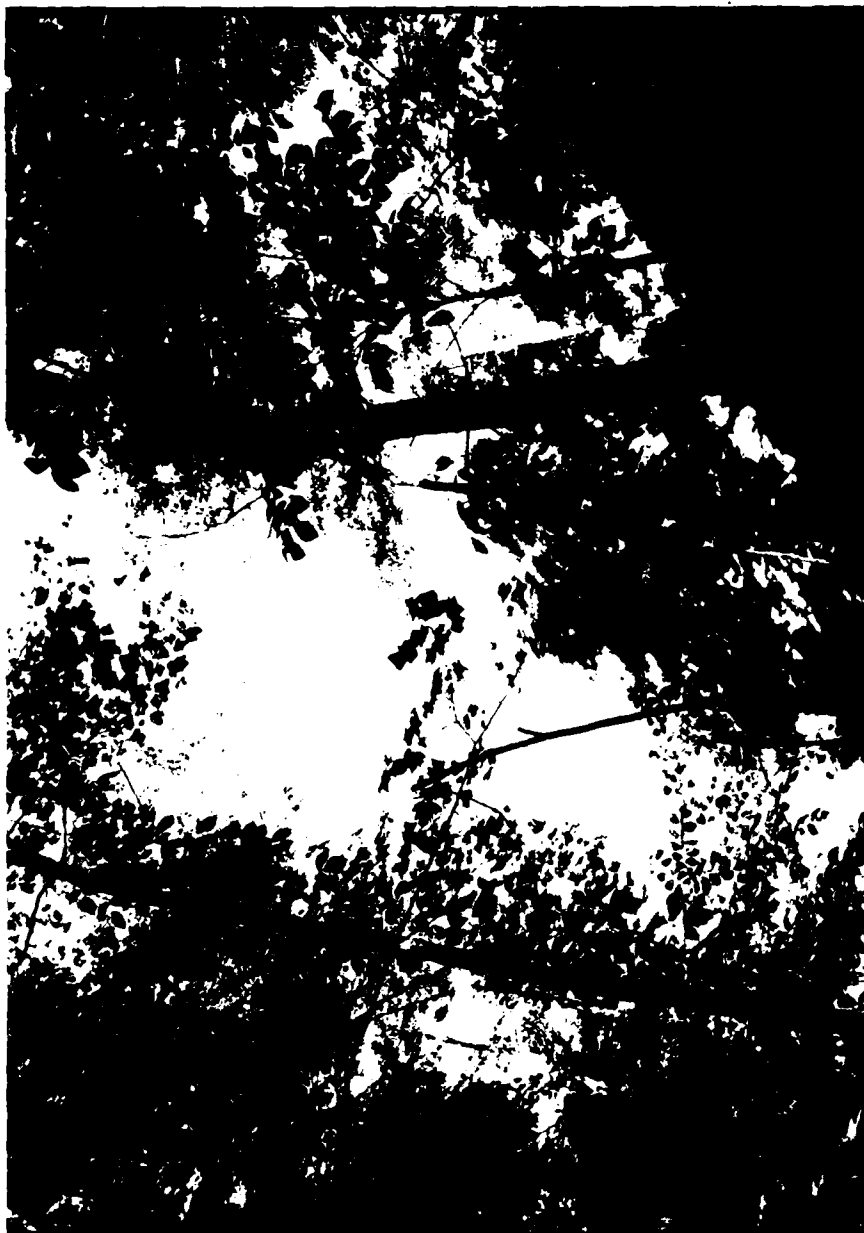
1. OVERVIEW OF DAM.

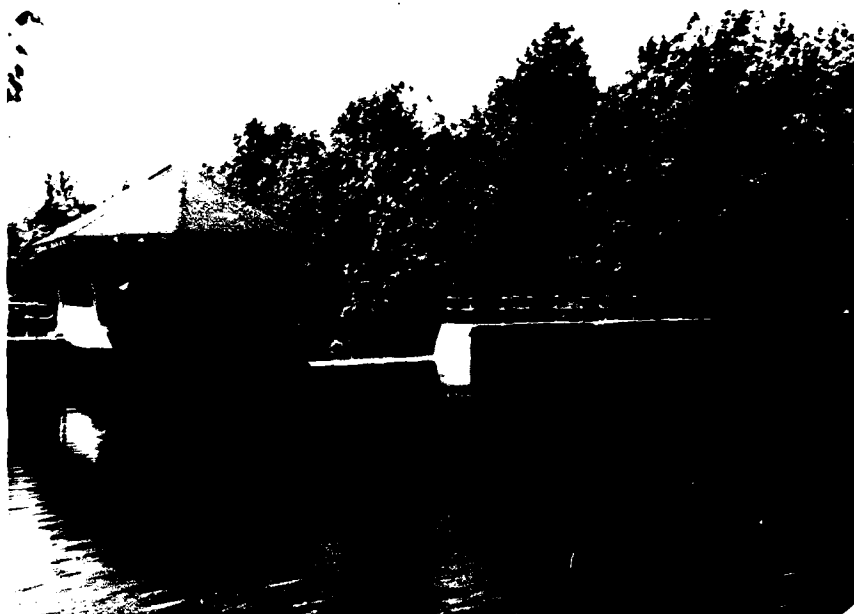
2. UPSTREAM VIEW OF DAM AND GATE HOUSE.

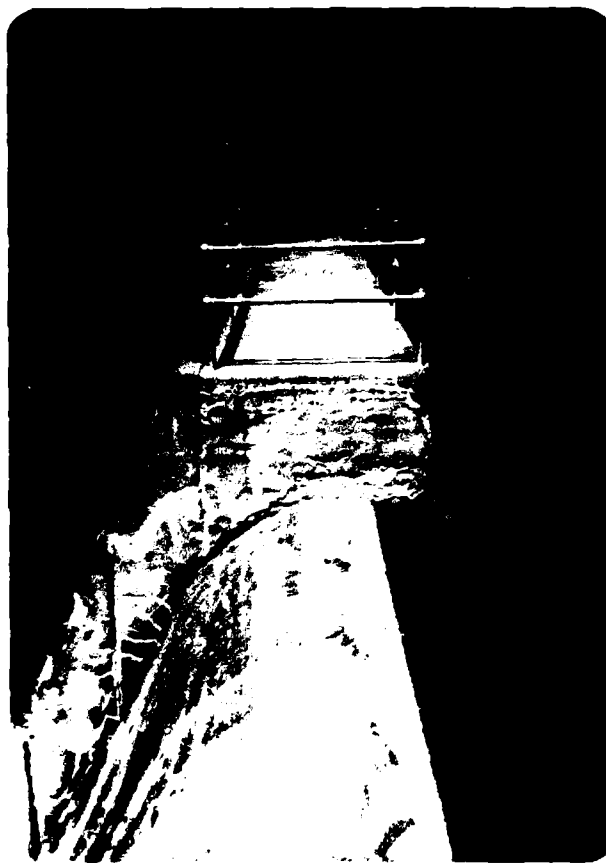
VIEW OF CREST OF SPILLWAY AND RIGHT
SIDE OF DAM.

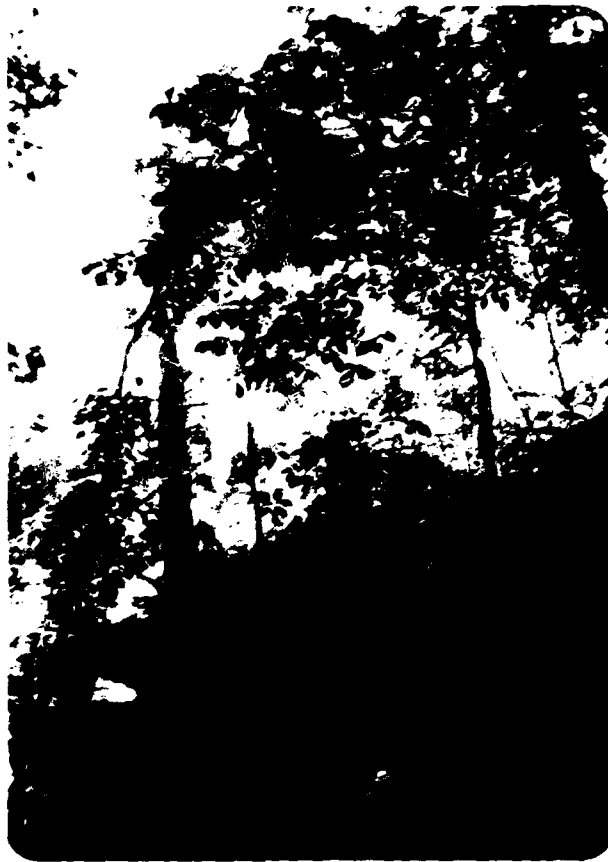
8. VIEW OF LOWER DOWNSTREAM FACE, SPILLWAY
TAILRACE TRAINING WALL AND VALVE HOUSE.
